**AIR FORCE FLIGHT DYNAMICS LABORATORY  
DIRECTOR OF LABORATORIES  
AIR FORCE SYSTEMS COMMAND  
WRIGHT PATTERSON AIR FORCE BASE OHIO**

**Crack Propagation Test Results for Variable  
Amplitude Spectrum Loading in Surface Flawed D6ac Steel**

Technical Memorandum FBR-71-2

February 1971

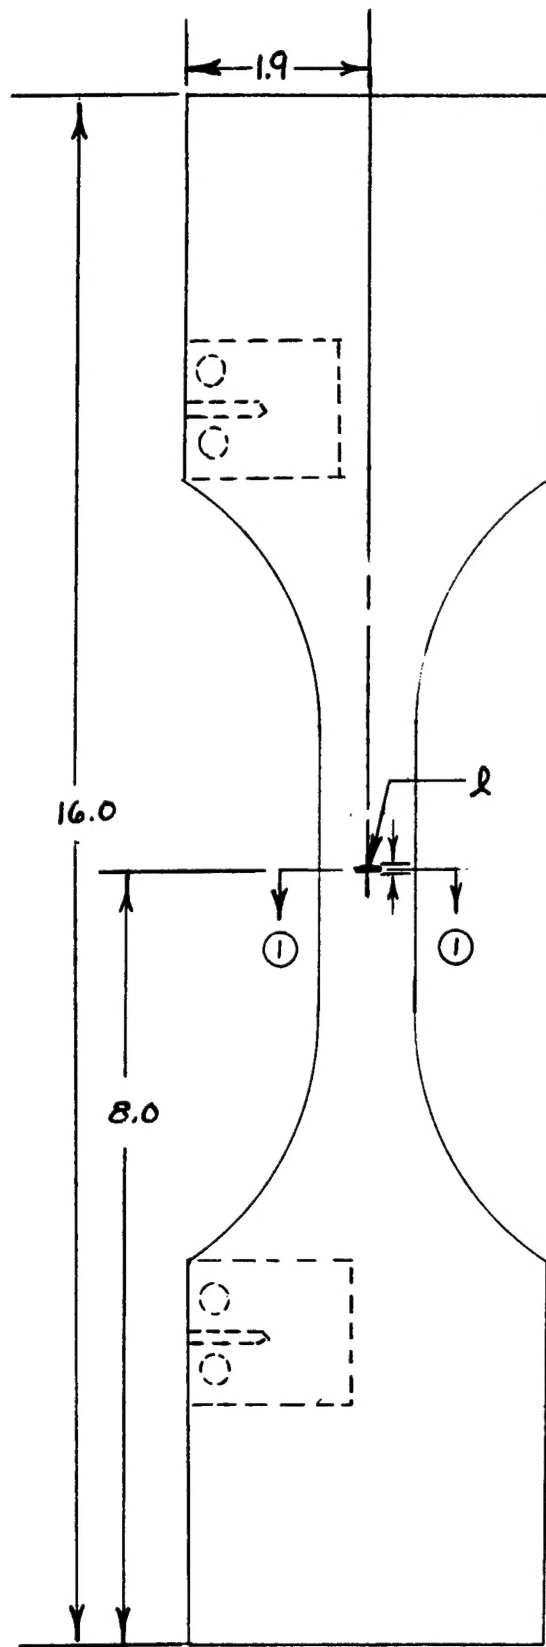
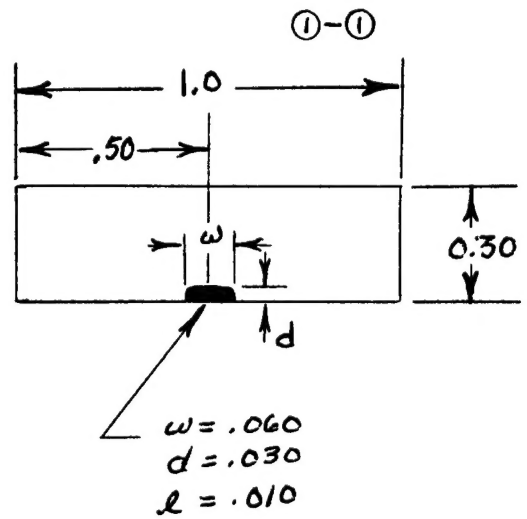
Figure 1  
AFFDL Crack Growth Test Specimen

Figure 1 includes the dimensions of the test specimen used throughout this program. The rectangular "starter flaw" was produced by the Elox (EDM) process to the dimensions indicated. Test machine capacity (50,000 lbs) limited the cross sectional area of the specimen to  $0.3 \text{ in}^2$ . The 0.3 in. thickness is representative of the critical Wing Pivot Fitting (WPF) location.

D6ac  
 $F_{ty} = 220-240$  KS1  
 Medium Fracture Toughness

Table V contains the compact tension results for  $K_{IC}$  for the majority of the test specimens. These specimens were removed from the broken halves as indicated in Figure 1. All  $K_{IC}$  testing was conducted by the Air Force Materials Laboratory (LAE).

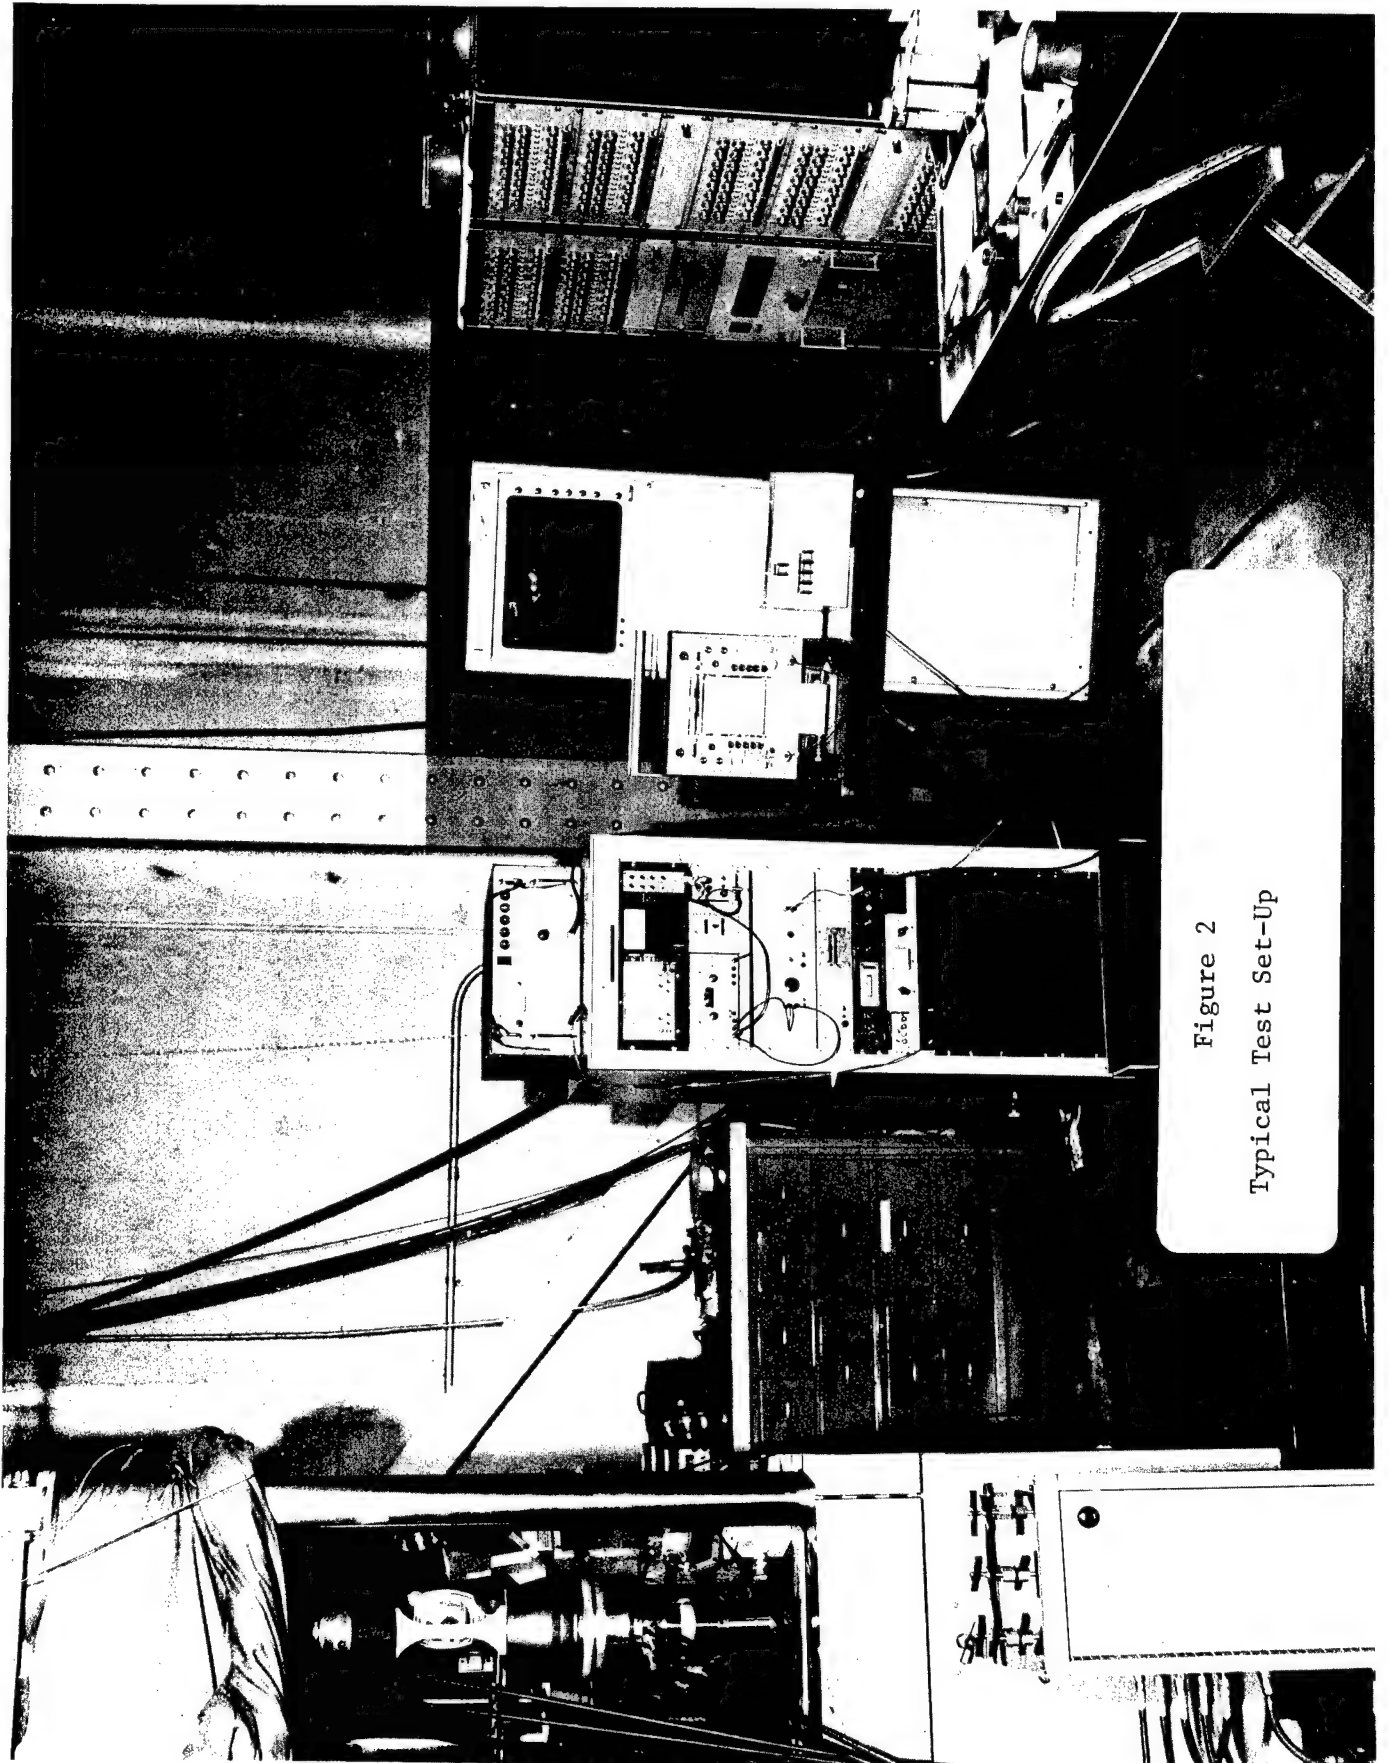
Figure 2  
Typical Test Set-Up

All testing was conducted on an MTS model 311.31 located in Building 65 at Wright-Patterson AFB, Ohio. This basic load frame has a capacity of 200 KIPS static and 100 KIPS dynamic loading; however, 50 KIP hydraulic grips were used throughout this program. All tests were conducted in laboratory air between June and October 1970. Relative humidity ranging between 40-90 percent can be expected during this time period. All spectrum tests were run at a rate of 5 Hertz. Precracking was conducted at a rate no greater than 9 Hertz.

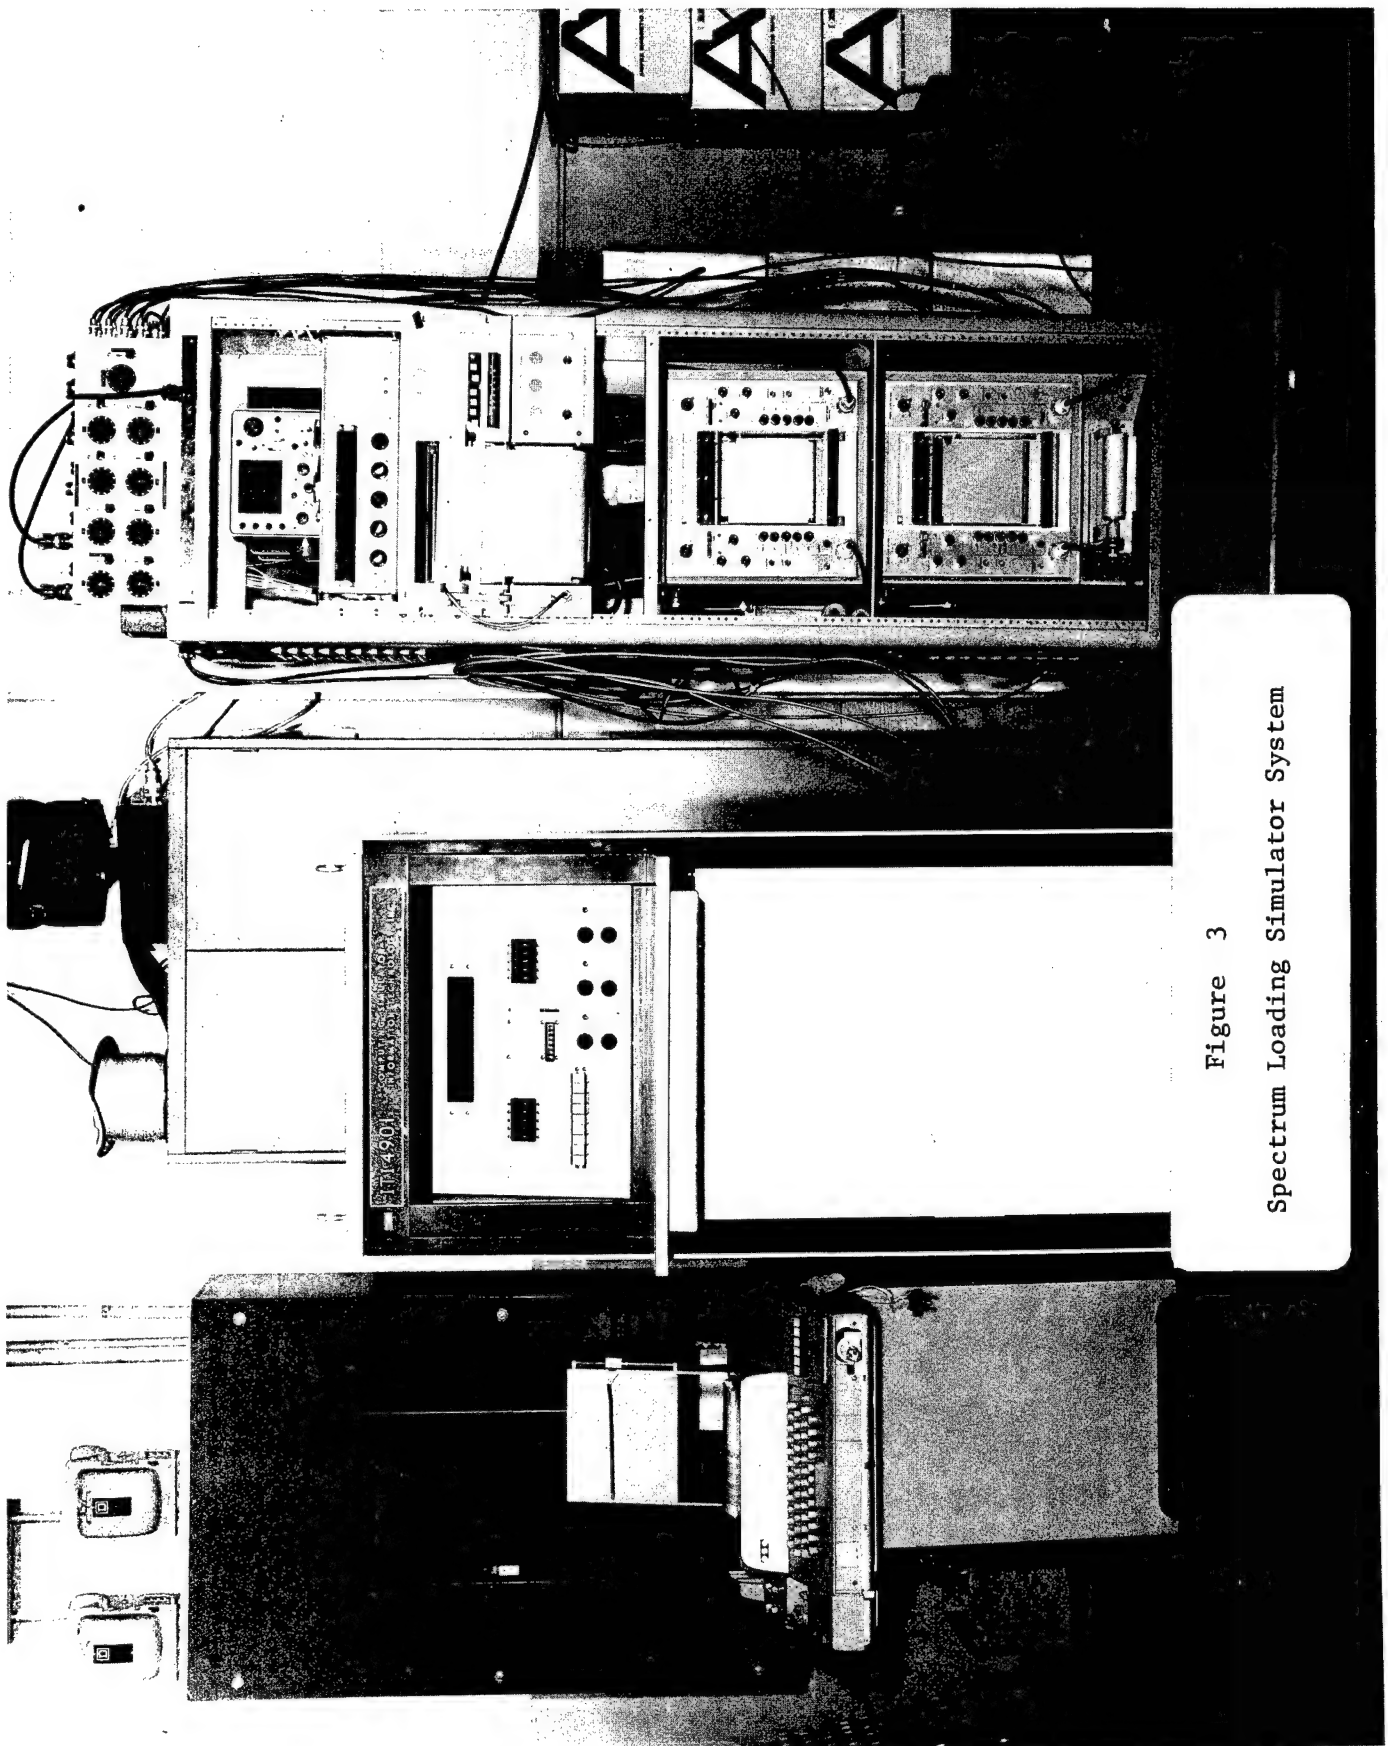
Figure 3  
Spectrum Loading Simulator System

The randomized block loading MAC wing pivot fitting stress spectra were obtained from General Dynamics, Fort Worth, and are contained in Table Ia, b, c. Each tabulation or block is representative of 200 flight hours. The 7.33g Tension-Compression spectrum was derived by modifying the basic 7.33g spectrum (Table Ib) to include the representative number of occurrences of negative load factor obtained from Reference 1. This loading sequence was programmed as input on paper tape into a digital computing simulator, (Information Technology, Inc.) model no. ITI 4901. The ITI simulates the spectrum loading as required and was used chiefly as a storage bank from which the loads could be repeatedly recalled in the form of 3 outputs of varying D.C. signals. The first channel was the actual load input which initially went through a limiting control circuit, set at 1% over the maximum load cycle. From this circuit, the signal was input as a demand function into a servo controller amplifier which controlled the test load. The output of channel number 2 was a verification of the mean load changes in the block spectrum, and also allowed verification of the number of cycles in each layer. The

third channel was used to trigger the strobe light synchronous with the maximum peak of each individual stress amplitude cycle. Continuous monitoring of the loading was accomplished with a two channel Sanborn recorder.

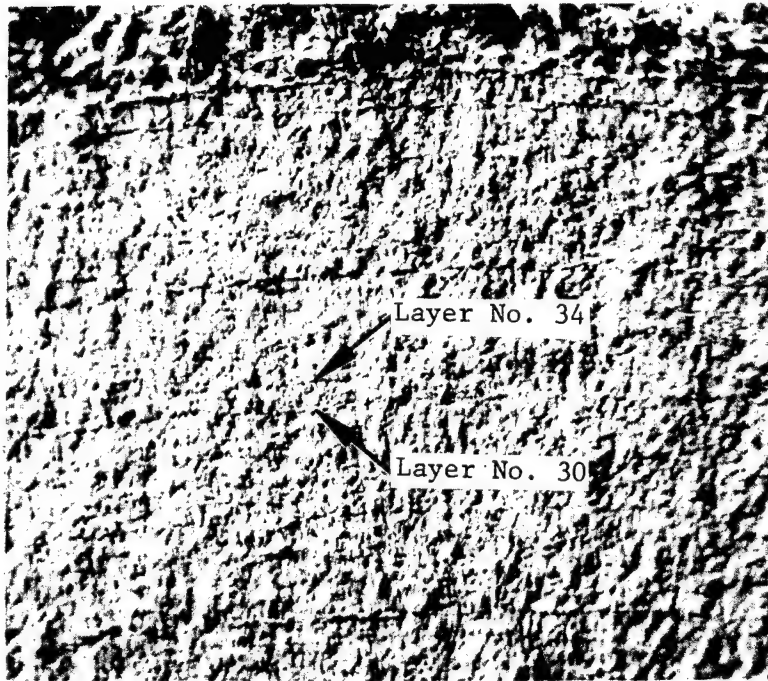
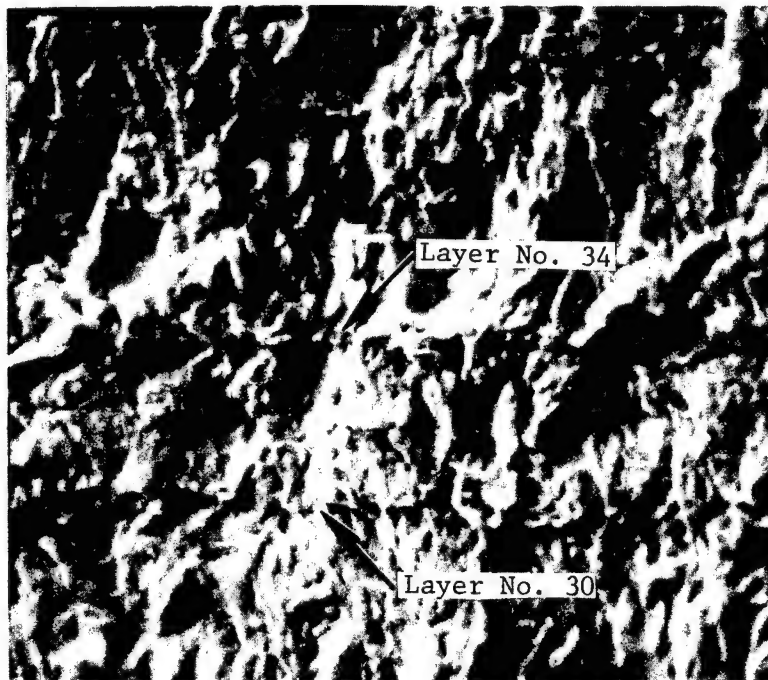
Figure 4 Scanning Electron Microscope Photographs

Convenient marker bands were produced on the fracture surface by the higher stress applications of the spectrum and were used to identify individual blocks. Other details such as the end of precracking and application of the single proof test cycle were generally recognized with this technique. In addition to the optical microscope, a scanning Electron Microscope was used. This device allowed more accurate interpretation of the "early" blocks (not normally distinguishable by optical means.) Figure 4a and 4b includes typical results from the Scanning Electron Microscope where layers 30 or 34 of the 5g spectrum are readily identified. Figure 4c includes a 100X composite of one half the cracked surface for a typical specimen obtained with the Scanning Electron Microscope.

100X

1000X

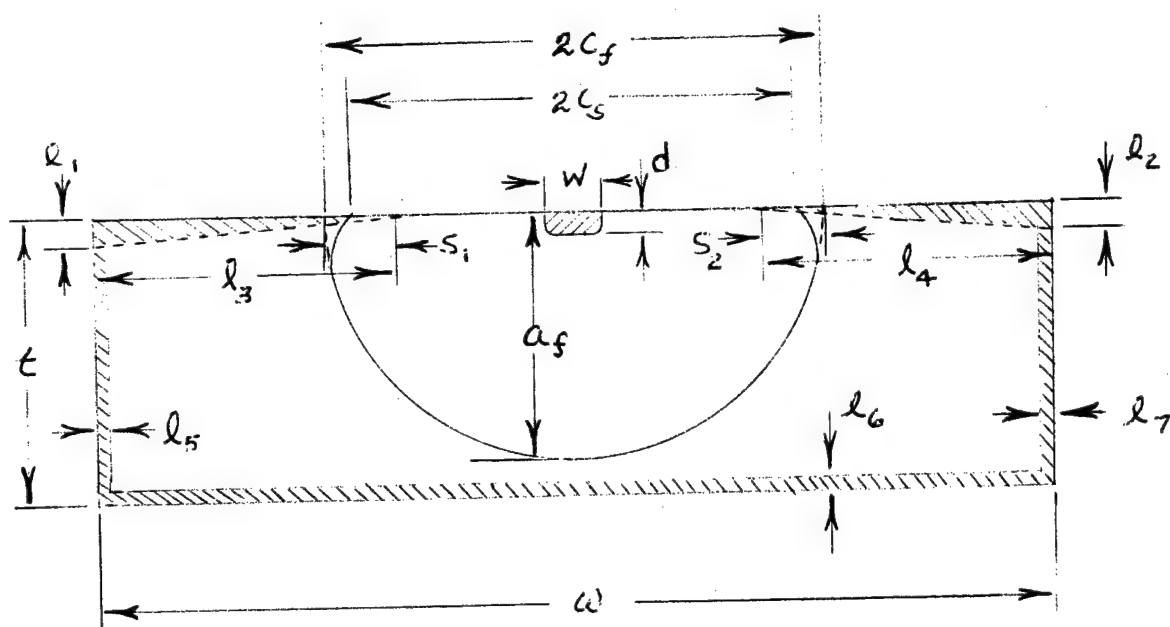
Table III Fracture Surface Geometry
